FINAL REPORT
NORTH ATLANTIC TELETYPE
ENGINEERING STUDY

VOLUME II

NORTH ATLANTIC TELETYPE
ENGINEERING STUDY

TASK 37
CONTRACT NO. AF19(628)-3358
REPORT NO. ICS-64-TR-441

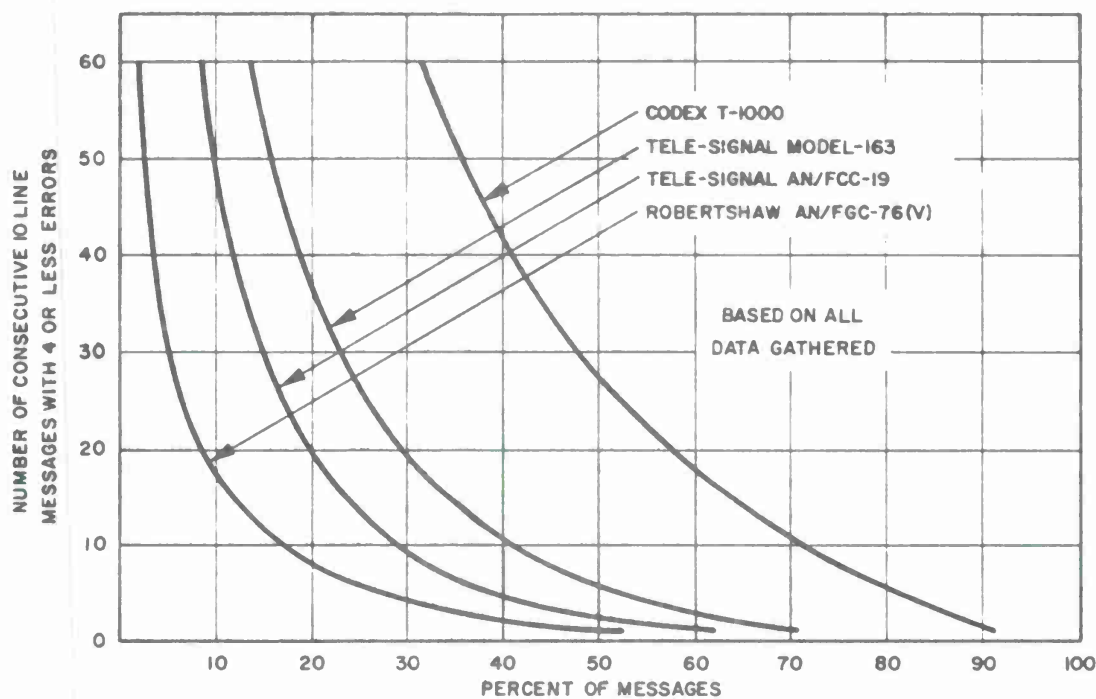
COMPARISON OF ALL EQUIPMENTS
(PERCENT-OF MESSAGES
RECEIVED WITH 4 OR LESS ERRORS)
FIGURE A-7

These curves are particularly useful since they indicate the percentage of time messages of various block lengths (1 block = 10 lines) were received with zero, two or less, and four or less errors per block during the test period. There was an even chance of receiving messages of 26, 5, 2, and 1 block lengths with four or less errors per block with the Codex

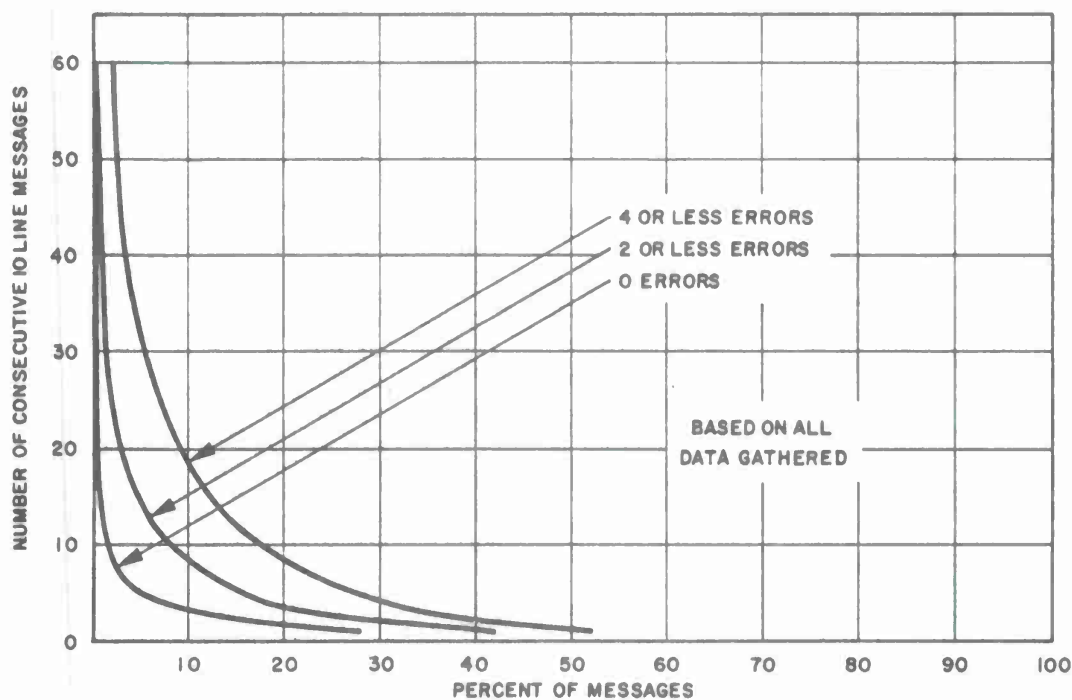
ERRORS PER MESSAGE
(USING ROBERTSHAW AN/FGC-76(V)PSK)
FIGURE A-8

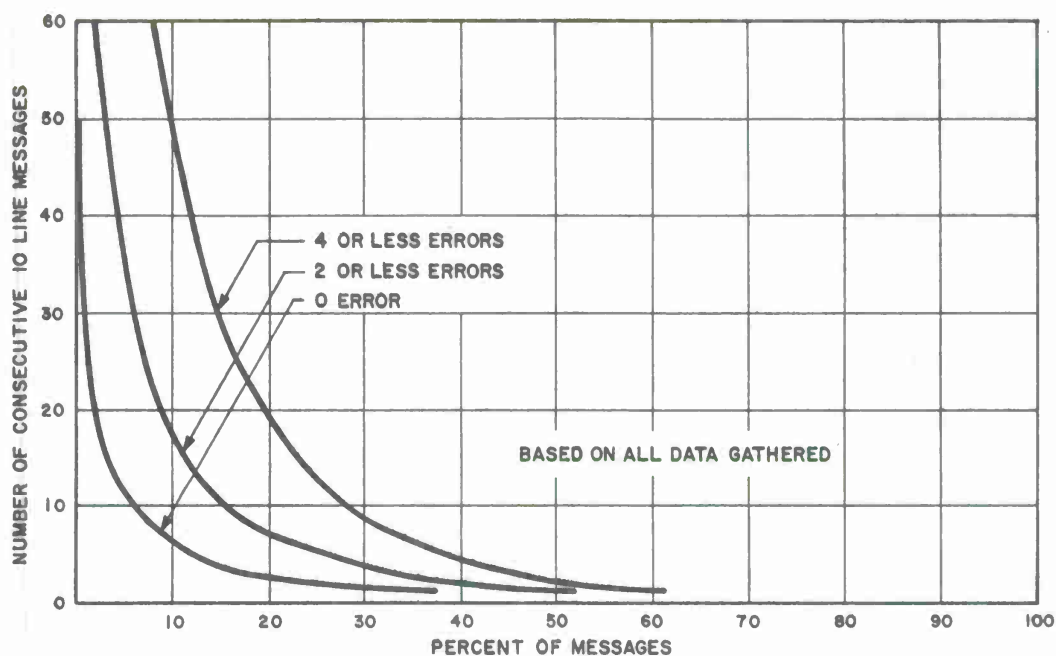
ERRORS PER MESSAGE
(USING TELE - SIGNAL AN/FCC-19 FSK)
FIGURE A-9

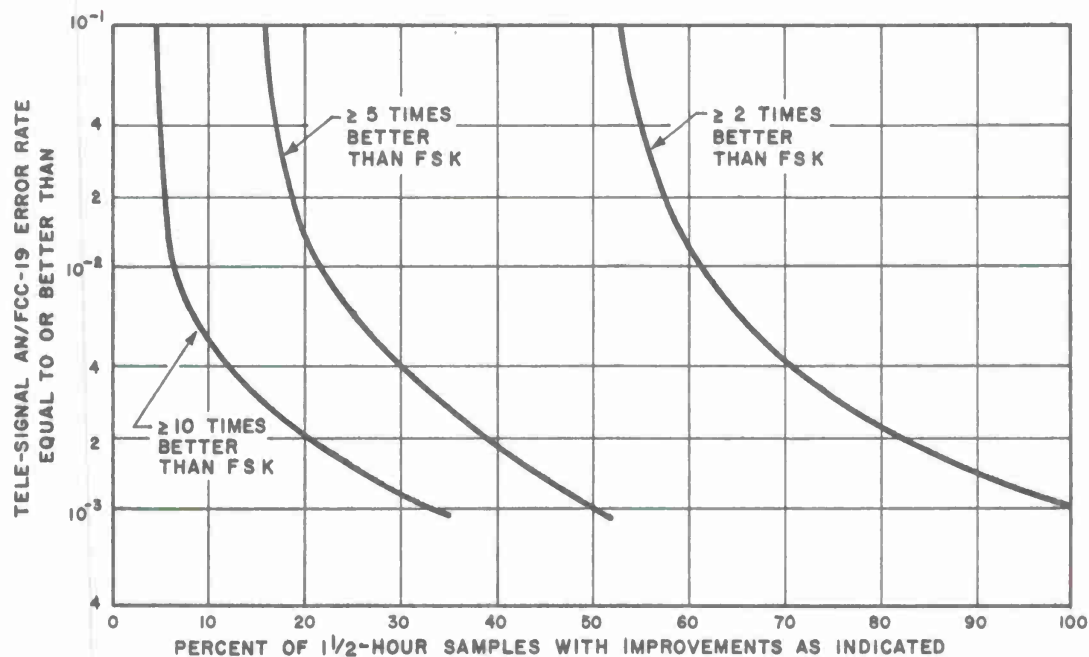
FIGURE A-15

IMPROVEMENT VERSUS PERCENT TIME
 (BASED ON COMPARISON OF 1/2-HOUR SAMPLES
 OF TELE-SIGNAL MODEL 163 AND AN/FCC-19)

A family of curves is presented in Figures A-14 and A-15 showing the percentage of samples for which the error correction equipment provided improvements equal to or greater than indicated, when the fsk error rate was less than or equal to that shown, on the ordinate. For example, Figure A-14

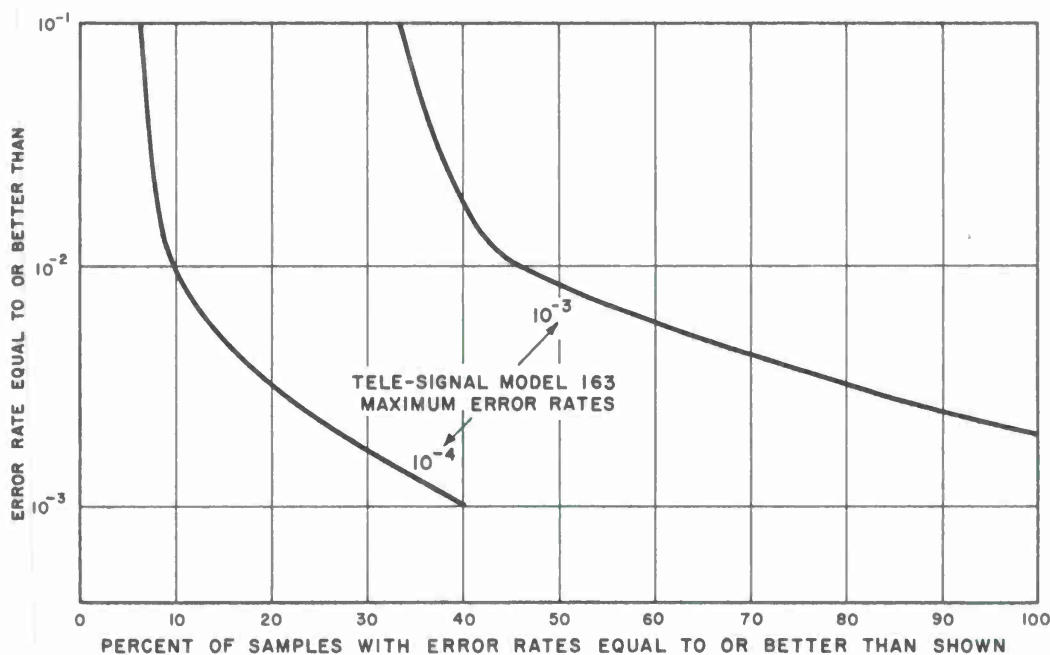
MAXIMUM ERROR RATE VERSUS PERCENT TIME

(BASED ON COMPARISONS OF 1½-HOUR SAMPLES
OF TELE-SIGNAL MODEL 163 AND AN/FCC-19)

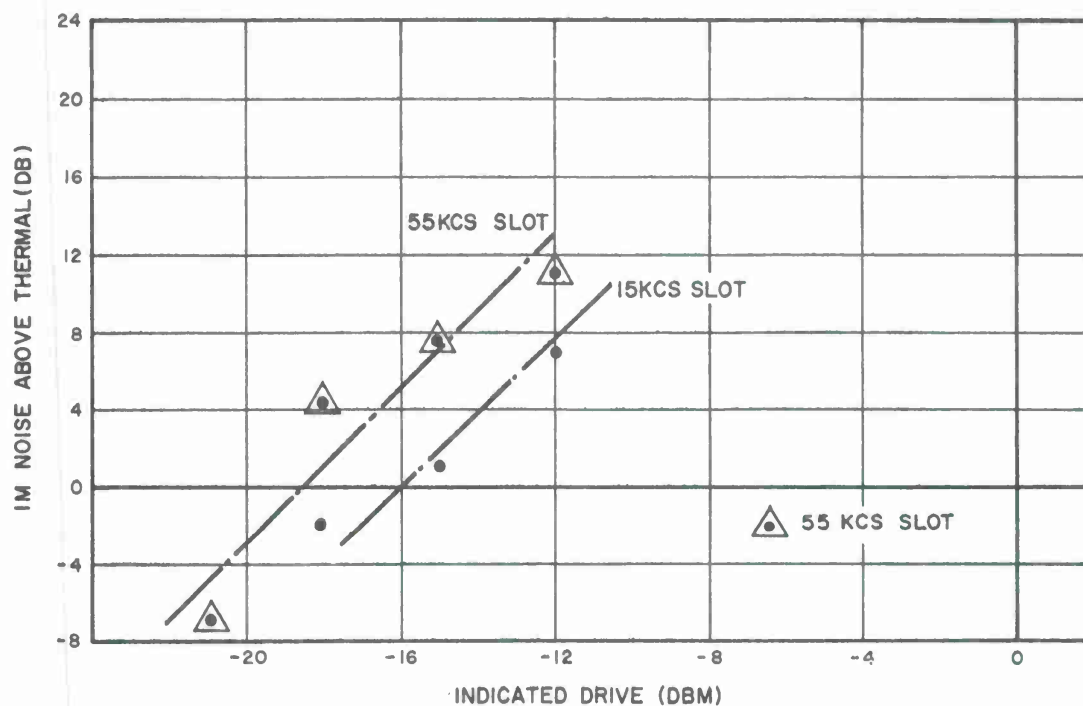
FIGURE B-9

AVERAGE IM NOISE ABOVE THERMAL FOR 60KCS TOP MODULATION
FREQUENCY, RADIO PATH DYE 4/5

The optimum levels from Figures B-3, B-4, B-6, B-7, B-9, and B-10 along with the current normal drive levels are shown in Table IV. It can be seen that the current normal practice is practically optimum for the path 43 to 44 for the "fully loaded" condition, and that deviation could be reduced for the path 42 to 41, and increased for the DYE-4 to DYE-5 path.

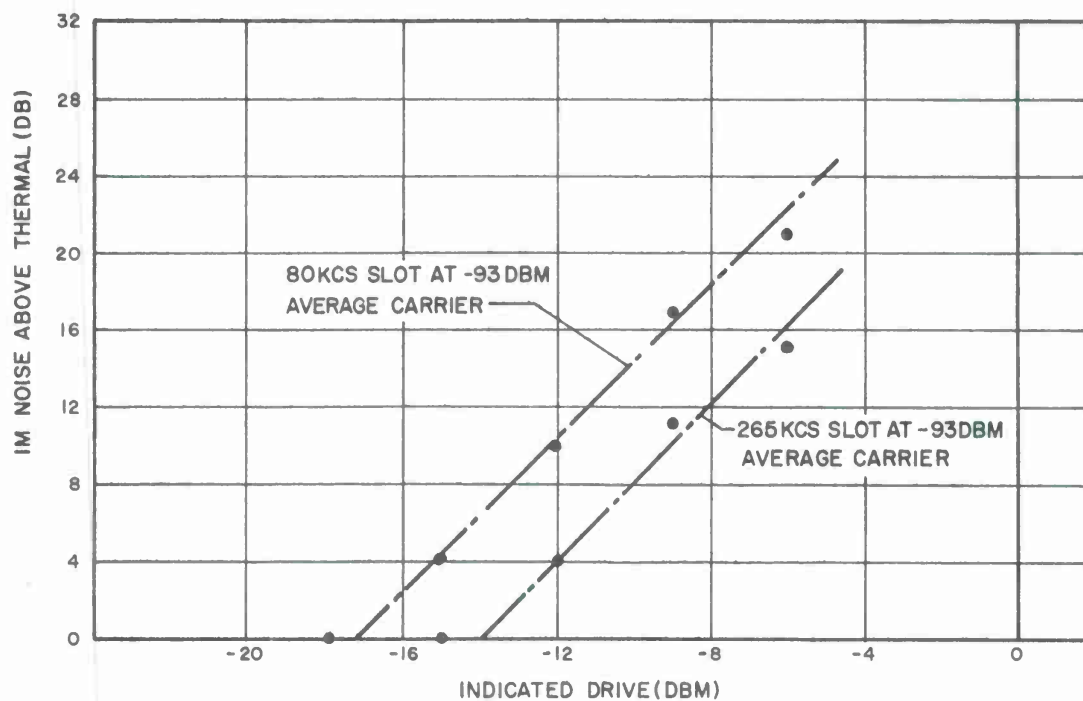
FIGURE B-10

AVERAGE IM NOISE ABOVE THERMAL FOR 308KCS TOP MODULATION
FREQUENCY, RADIO PATH DYE 4/5
